**ASBESTOS MANAGEMENT SURVEY
OF
1 CLAYDON SCOUT GROUP, KIRBY RISE, BARHAM, IP6 0AU**

**CLIENT: 1ST CLAYDON SCOUT GROUP
KIRBY RISE, BARHAM, IP6 0AU**

**UPRN NO: N/A
PROJECT NO: J543357
DATE: AUGUST 2019**

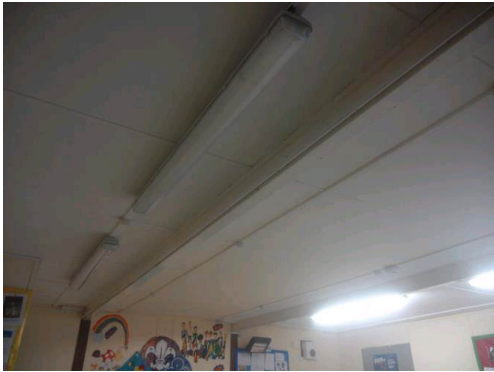
FLOOR/LOCATION:	Ground Floor G.01	
DESCRIPTION:	Cement ceiling panels	
RECOMMENDATIONS:	Manage, monitor and inform maintenance personnel prior to relevant works	
EXTENT:	10 - 50 m ² or 10 - 50m pipe run	
SAMPLE REF:	IX001664	
RESULT:	Chrysotile

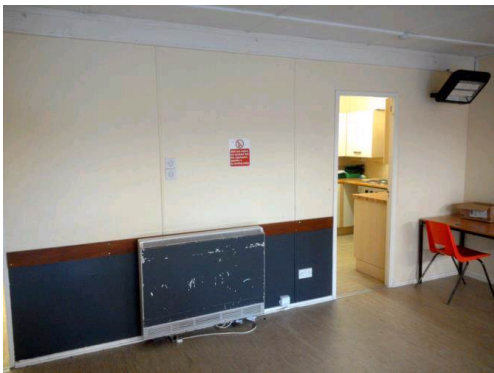
FLOOR/LOCATION:	Ground Floor G.01	
DESCRIPTION:	Cement wall panels	
RECOMMENDATIONS:	Manage, monitor and inform maintenance personnel prior to relevant works	
EXTENT:	10 - 50 m ² or 10 - 50m pipe run	
SAMPLE REF:	IX001669	
RESULT:	Chrysotile

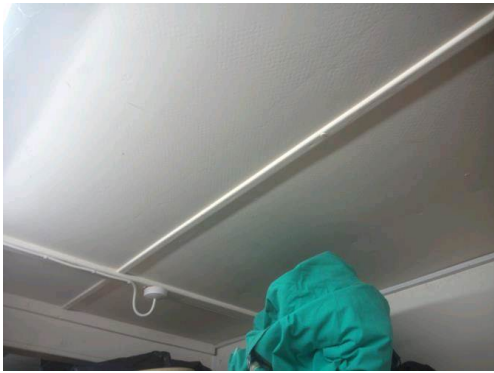
FLOOR/LOCATION:	Ground Floor G.03	
DESCRIPTION:	Cement ceiling panels	
RECOMMENDATIONS:	Manage, monitor and inform maintenance personnel prior to relevant works	
EXTENT:	10 - 50 m ² or 10 - 50m pipe run	
SAMPLE REF:	IX001665	
RESULT:	Chrysotile

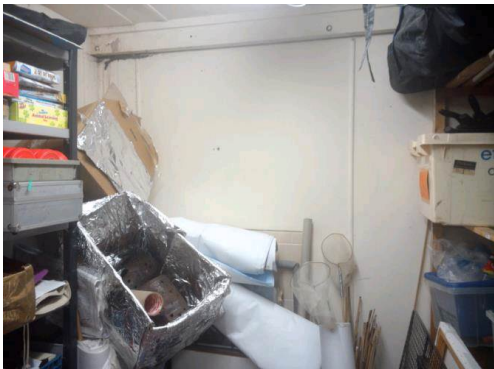
FLOOR/LOCATION:	Ground Floor G.03	
DESCRIPTION:	Cement wall panels	
RECOMMENDATIONS:	Manage, monitor and inform maintenance personnel prior to relevant works	
EXTENT:	<10m ² or <10m pipe run	
SAMPLE REF:	IX001666	
RESULT:	Chrysotile

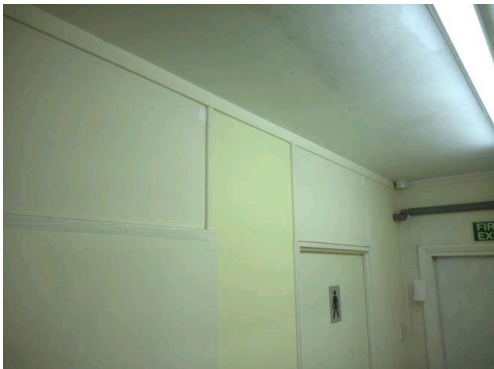
Man	Ground Floor / G.04 (1)	1 - 3 (1)	Cement header panels (1)	1m ² (1)	Sealed (0)	Low Damage (1)	Low (1)	Strongly presumed similar to IX001666 / Chrysotile (1)	3 + 4 = 7	Very Low	Manage, monitor and inform maintenance personnel prior to relevant works
Man	Ground Floor / G.04	-	All other areas visually no asbestos identified	-	-	-	-		-	-	No further action required
	Ground Floor / G.04		Plasterboard ceiling panels, timber framework, plasterboard/timber wall panels, timber floor, timber door/frame, vinyl floor covering to hardboard floor.								
Man	Ground Floor / G.05 (1)	1 - 3 (1)	Cement ceiling panels (1)	1m ² (1)	Sealed (0)	Low Damage (1)	Low (1)	Strongly presumed similar to IX001665 / Chrysotile (1)	3 + 4 = 7	Very Low	Manage, monitor and inform maintenance personnel prior to relevant works

FLOOR/LOCATION:	Ground Floor G.04	
DESCRIPTION:	Cement header panels	
RECOMMENDATIONS:	Manage, monitor and inform maintenance personnel prior to relevant works	
EXTENT:	<10m ² or <10m pipe run	
SAMPLE REF:	SPST IX001666	
RESULT:	Chrysotile

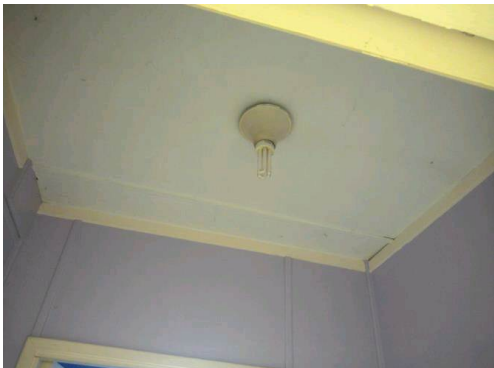
FLOOR/LOCATION:	Ground Floor G.05	
DESCRIPTION:	Cement ceiling panels	
RECOMMENDATIONS:	Manage, monitor and inform maintenance personnel prior to relevant works	
EXTENT:	<10m ² or <10m pipe run	
SAMPLE REF:	SPST IX001665	
RESULT:	Chrysotile

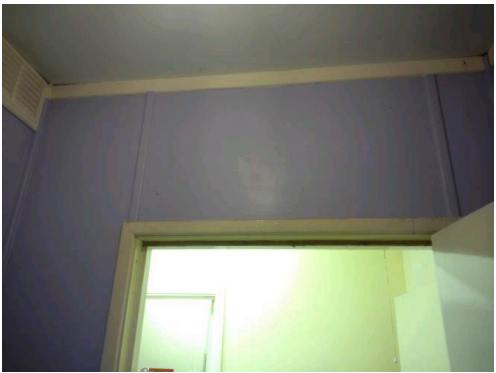
FLOOR/LOCATION:	Ground Floor G.05	
DESCRIPTION:	Cement wall panels	
RECOMMENDATIONS:	Manage, monitor and inform maintenance personnel prior to relevant works	
EXTENT:	<10m ² or <10m pipe run	
SAMPLE REF:	SPST IX001666	
RESULT:	Chrysotile

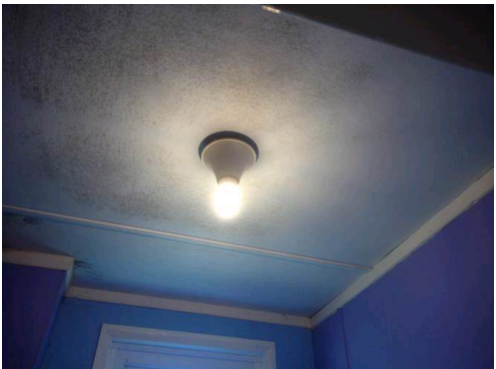
Man	Ground Floor / G.06 (1)	1 - 3 (1)	Cement ceiling panels (1)	2m ² (1)	Sealed (0)	Low Damage (1)	Low (1)	Strongly presumed similar to IX001665 / Chrysotile (1)	3 + 4 = 7	Very Low	Manage, monitor and inform maintenance personnel prior to relevant works	
Man	Ground Floor / G.06 (1)	1 - 3 (1)	Cement wall panels (1)	8m ² (1)	Sealed (0)	Low Damage (1)	Medium (2)	Strongly presumed similar to IX001666 / Chrysotile (1)	3 + 5 = 8	Very Low	Manage, monitor and inform maintenance personnel prior to relevant works	
Man	Ground Floor / G.06	-	All other areas visually no asbestos identified	-	-	-	-		-	-	No further action required	
Man	Ground Floor / G.06	-	Cement ceiling panels, timber framework, plasterboard/timber wall panels, timber floor, timber door/frame, UPVC window frame, plastic cistern, uninsulated metal/plastic pipework, foam insulated metal pipework, timber boxing, vinyl floor covering to hardboard floor.

FLOOR/LOCATION:	Ground Floor G.06	
DESCRIPTION:	Cement ceiling panels	
RECOMMENDATIONS:	Manage, monitor and inform maintenance personnel prior to relevant works	
EXTENT:	<10m ² or <10m pipe run	
SAMPLE REF:	SPST IX001665	
RESULT:	Chrysotile

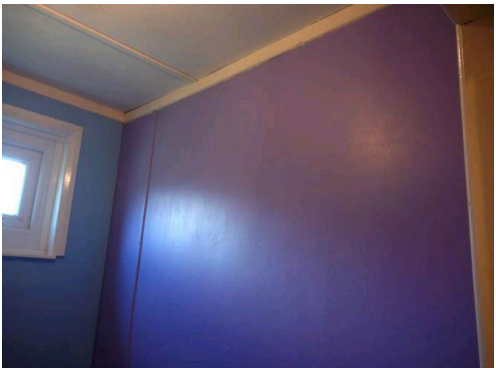
FLOOR/LOCATION:	Ground Floor G.06	
DESCRIPTION:	Cement wall panels	
RECOMMENDATIONS:	Manage, monitor and inform maintenance personnel prior to relevant works	
EXTENT:	<10m ² or <10m pipe run	
SAMPLE REF:	SPST IX001666	
RESULT:	Chrysotile

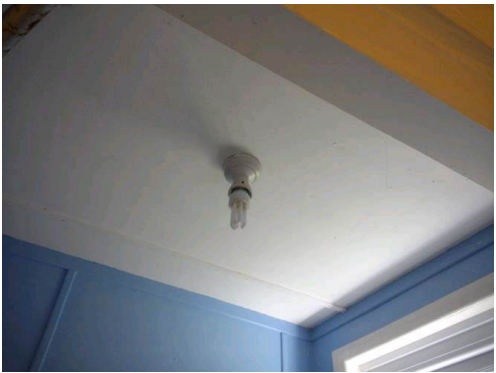
FLOOR/LOCATION:	Ground Floor G.07	
DESCRIPTION:	Cement ceiling panels	
RECOMMENDATIONS:	Manage, monitor and inform maintenance personnel prior to relevant works	
EXTENT:	<10m ² or <10m pipe run	
SAMPLE REF:	SPST IX001665	
RESULT:	Chrysotile

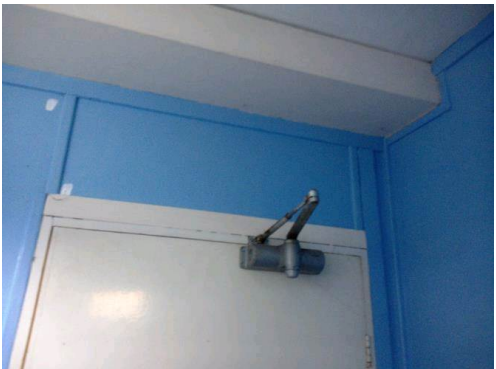
FLOOR/LOCATION:	Ground Floor G.07	
DESCRIPTION:	Cement wall panels	
RECOMMENDATIONS:	Manage, monitor and inform maintenance personnel prior to relevant works	
EXTENT:	<10m ² or <10m pipe run	
SAMPLE REF:	SPST IX001666	
RESULT:	Chrysotile

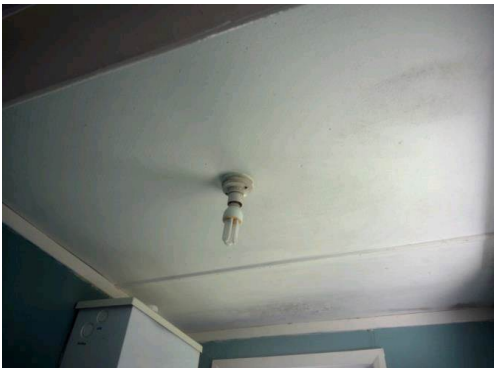
FLOOR/LOCATION:	Ground Floor G.08	
DESCRIPTION:	Cement ceiling panels	
RECOMMENDATIONS:	Manage, monitor and inform maintenance personnel prior to relevant works	
EXTENT:	<10m ² or <10m pipe run	
SAMPLE REF:	SPST IX001665	
RESULT:	Chrysotile

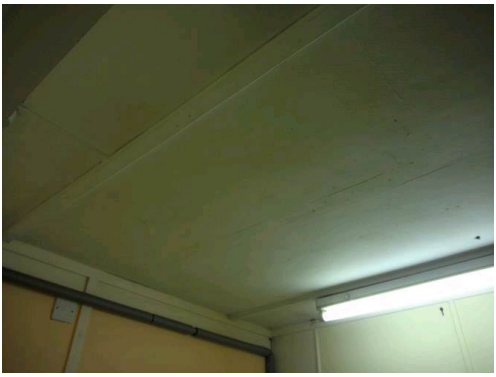
FLOOR/LOCATION:	Ground Floor G.09	
DESCRIPTION:	Cement ceiling panels	
RECOMMENDATIONS:	Manage, monitor and inform maintenance personnel prior to relevant works	
EXTENT:	<10m ² or <10m pipe run	
SAMPLE REF:	IX001667	
RESULT:	Chrysotile

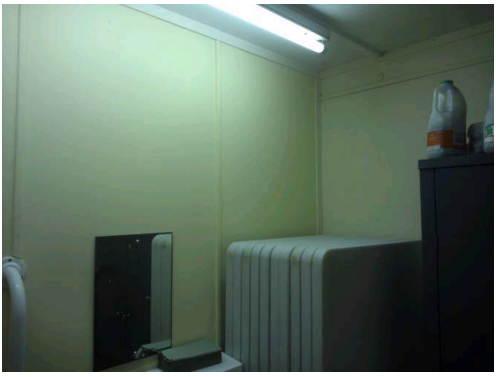
Man	Ground Floor / G.09 (1)	1 - 3 (1)	Cement wall panels (1)	8m ² (1)	Sealed (0)	Low Damage (1)	Medium (2)	IX001668 / Chrysotile (1)	3 + 5 = 8	Very Low	Manage, monitor and inform maintenance personnel prior to relevant works
Man	Ground Floor / G.09	-	All other areas visually no asbestos identified	-	-	-	-		-	-	No further action required
	Ground Floor / G.09		Cement ceiling panels, timber framework, plasterboard/timber wall panels, timber floor, timber door/frame, UPVC window frame, plastic cistern, uninsulated metal/plastic pipework, foam insulated metal pipework, timber boxing, vinyl floor covering to hardboard floor.								
Man	Ground Floor / G.10 (1)	1 - 3 (1)	Cement ceiling panels (1)	9m ² (1)	Sealed (0)	Low Damage (1)	Low (1)	Strongly presumed similar to IX001667 / Chrysotile (1)	3 + 4 = 7	Very Low	Manage, monitor and inform maintenance personnel prior to relevant works

FLOOR/LOCATION:	Ground Floor G.09	
DESCRIPTION:	Cement wall panels	
RECOMMENDATIONS:	Manage, monitor and inform maintenance personnel prior to relevant works	
EXTENT:	<10m ² or <10m pipe run	
SAMPLE REF:	IX001668	
RESULT:	Chrysotile

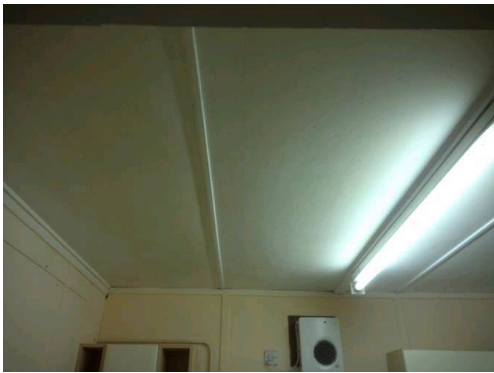
FLOOR/LOCATION:	Ground Floor G.10	
DESCRIPTION:	Cement ceiling panels	
RECOMMENDATIONS:	Manage, monitor and inform maintenance personnel prior to relevant works	
EXTENT:	<10m ² or <10m pipe run	
SAMPLE REF:	SPST IX001667	
RESULT:	Chrysotile

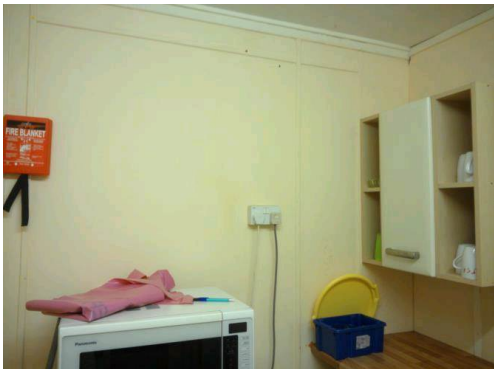
FLOOR/LOCATION:	Ground Floor G.10	
DESCRIPTION:	Cement wall panels	
RECOMMENDATIONS:	Manage, monitor and inform maintenance personnel prior to relevant works	
EXTENT:	<10m ² or <10m pipe run	
SAMPLE REF:	SPST IX001668	
RESULT:	Chrysotile

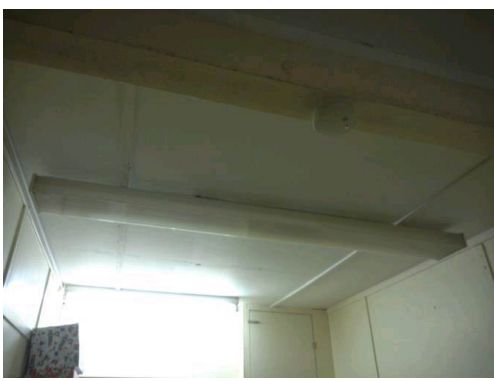
Man	Ground Floor / G.11 (1)	1 - 3 (1)	Cement ceiling panels (1)	10m ² (2)	Sealed (0)	Low Damage (1)	Low (1)	Strongly presumed similar to IX001667 / Chrysotile (1)	3 + 5 = 8	Very Low	Manage, monitor and inform maintenance personnel prior to relevant works	
Man	Ground Floor / G.11 (1)	1 - 3 (1)	Cement wall panels (1)	20m ² (2)	Sealed (0)	Low Damage (1)	Medium (2)	Strongly presumed similar to IX001668 / Chrysotile (1)	3 + 6 = 9	Very Low	Manage, monitor and inform maintenance personnel prior to relevant works	
Man	Ground Floor / G.11	-	All other areas visually no asbestos identified	-	-	-	-		-	-	No further action required	
	Ground Floor / G.11		Cement ceiling panels, timber framework, plasterboard/timber wall panels, timber floor, timber door/frame, vinyl floor covering to hardboard floor.									
Indicates parameter for Material Assessment algorithm(MA)			Product type *C Surface Treatment *E Extent of damage *F Asbestos Type *H					Priority Rating: Very low <9 Low 10-12 Medium 13-15 High ≥16

FLOOR/LOCATION:	Ground Floor G.11	
DESCRIPTION:	Cement ceiling panels	
RECOMMENDATIONS:	Manage, monitor and inform maintenance personnel prior to relevant works	
EXTENT:	10 - 50 m ² or 10 - 50m pipe run	
SAMPLE REF:	SPST IX001667	
RESULT:	Chrysotile

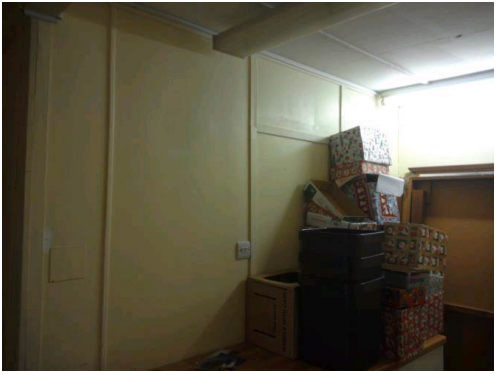
FLOOR/LOCATION:	Ground Floor G.11	
DESCRIPTION:	Cement wall panels	
RECOMMENDATIONS:	Manage, monitor and inform maintenance personnel prior to relevant works	
EXTENT:	10 - 50 m ² or 10 - 50m pipe run	
SAMPLE REF:	SPST IX001668	
RESULT:	Chrysotile

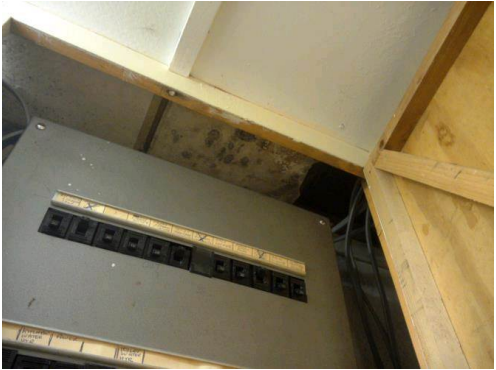
FLOOR/LOCATION:	Ground Floor G.12	
DESCRIPTION:	Cement ceiling panels	
RECOMMENDATIONS:	Encapsulate	
EXTENT:	<10m ² or <10m pipe run	
SAMPLE REF:	SPST IX001667	
RESULT:	Chrysotile

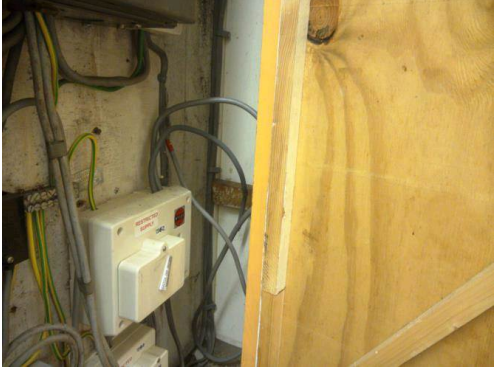
FLOOR/LOCATION:	Ground Floor G.12	
DESCRIPTION:	Cement wall panels	
RECOMMENDATIONS:	Manage, monitor and inform maintenance personnel prior to relevant works	
EXTENT:	<10m ² or <10m pipe run	
SAMPLE REF:	SPST IX001668	
RESULT:	Chrysotile

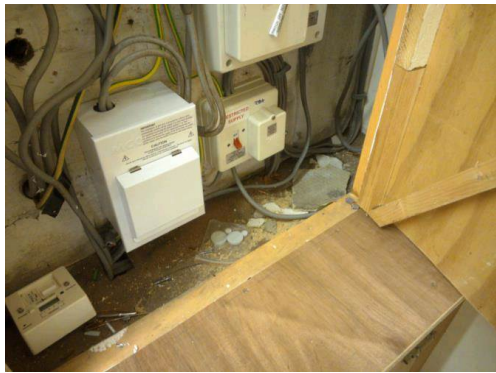
Man	Ground Floor / G.12 (1)	1 - 3 (1)	Cement debris to cupboard shelf (1)	<1m ² (1)	Debris/Loose material (3)	High Damage (3)	High (3)	IX001670 / Chrysotile (1)	8 + 6 = 14	Medium	Restrict access, remove and/or decontaminate area
Man	Ground Floor / G.12	-	All other areas visually no asbestos identified	-	-	-	-	-	-	-	No further action required
Man	Ground Floor / G.12	-	Cement ceiling panels, timber framework, plasterboard/timber wall panels, timber floor, timber door/frame, modern electrical units, vinyl floor covering to hardboard floor.	-	-	-	-	-	-	-	No further action required
Man	External / External	None	Textured coating to walls	<200m ²	Sealed	Low Damage	Medium	IX001671 / No Asbestos Detected	-	-	No further action required

BUILDING NAME:	Main
FLOOR/LOCATION:	Ground Floor G.12
DESCRIPTION:	Cement debris to cupboard shelf
RECOMMENDATIONS:	Restrict access, remove and/or decontaminate area
EXTENT:	<10m ² or <10m pipe run
SAMPLE REF:	IX001670
RESULT:	Chrysotile
